The Performance of House Foundations in the Canterbury Earthquakes

Master of Engineering in Civil Engineering

Duncan Henderson

August, 2013

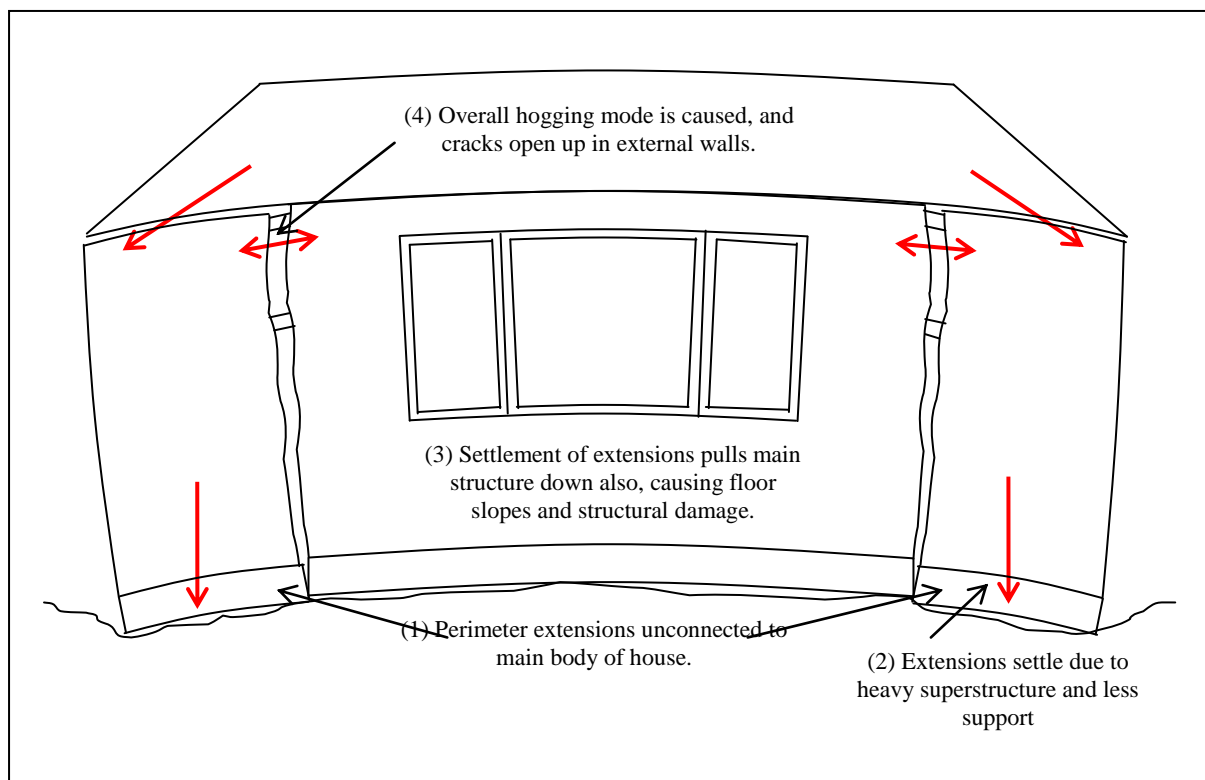
This house had a unique mode of deformation caused by the settlement of two small extensions on the Southwest and Southeast arms of the 'T' shaped house (Figure 5.12).

Figure 5.12. Schematic elevation A-A showing the deformation mode of House #2, looking towards the North from the back of the house.

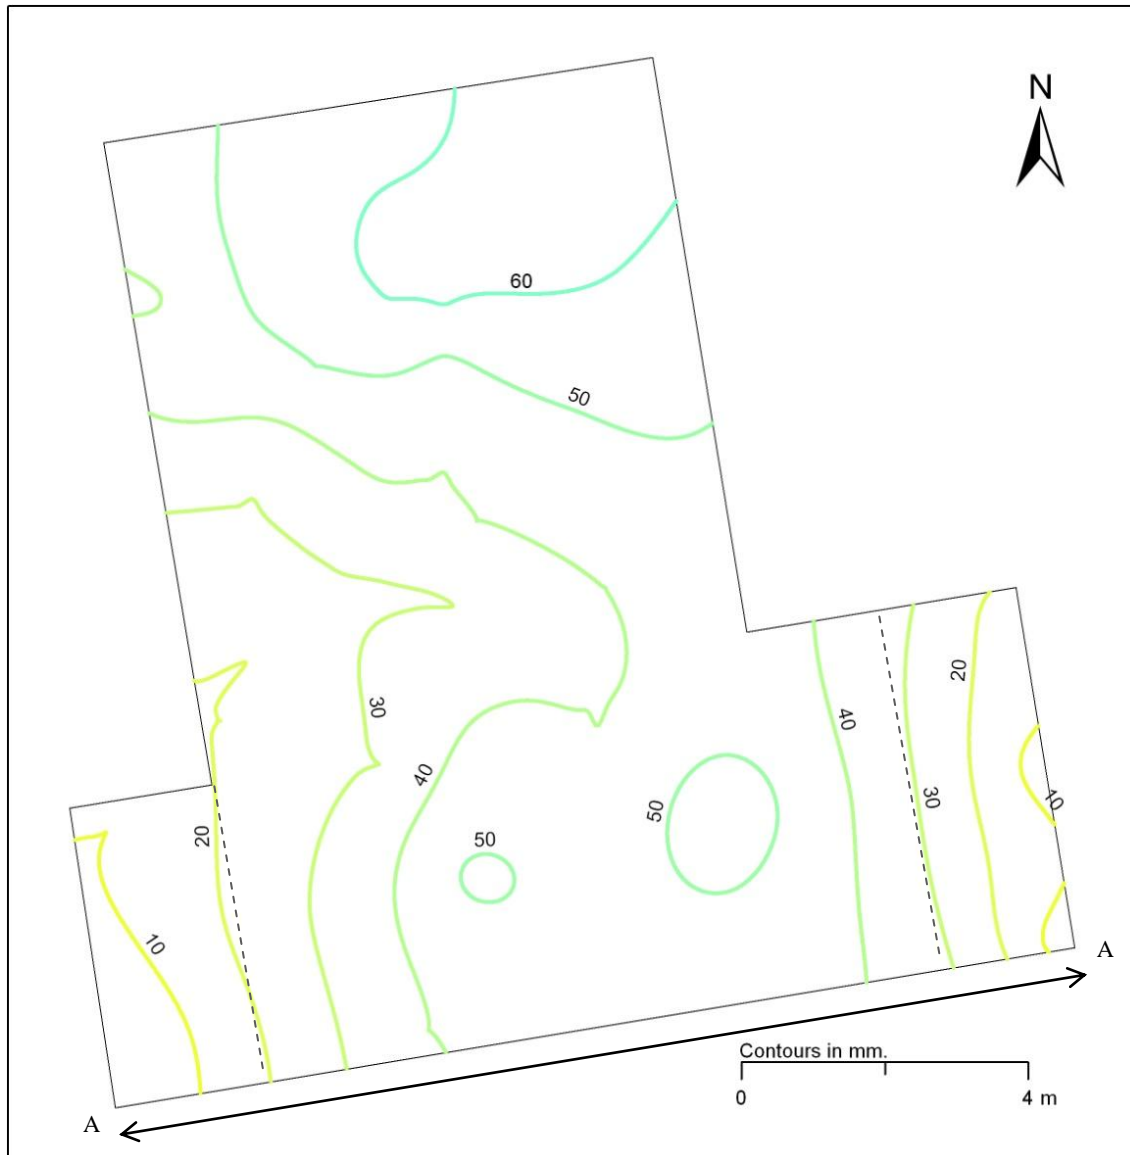
The house was generally level along its major axis, North to South (Figure 5.13) with only 10-20mm difference in floor level between the middle of the North and South walls. The perimeter foundations of the extensions, shown in Figure 5.13 with dashed lines, were not structurally attached to the rest of the house, but sitting beside it, as shown in Figure 5.12 and Figure 5.14.(a). This meant that the structure could not act as a cohesive system, and these extensions were not aided by the flexural strength and stiffness of the main body of the foundation. This meant that the foundations of the extensions settled more than the main body of the house. They dragged the rest of the Southern part of the house down with them, as the sections of foundation were still connected through the superstructure, which still acted as one unit. This caused significant hogging of up to 50mm across the Southern part of the foundation, as shown by Figure 5.12 and Figure 5.13, and resulted in significant structural damage in this area. Two doorways showed evidence of racking, and major vertical structural cracks opened up in the walls either side of where the East extension joined to the old house, one of which is shown in Figure 5.14.(b).

Figure 5.13. House #2 floor plan outline showing floor level contours in 10mm increments and extensions with dashed lines.

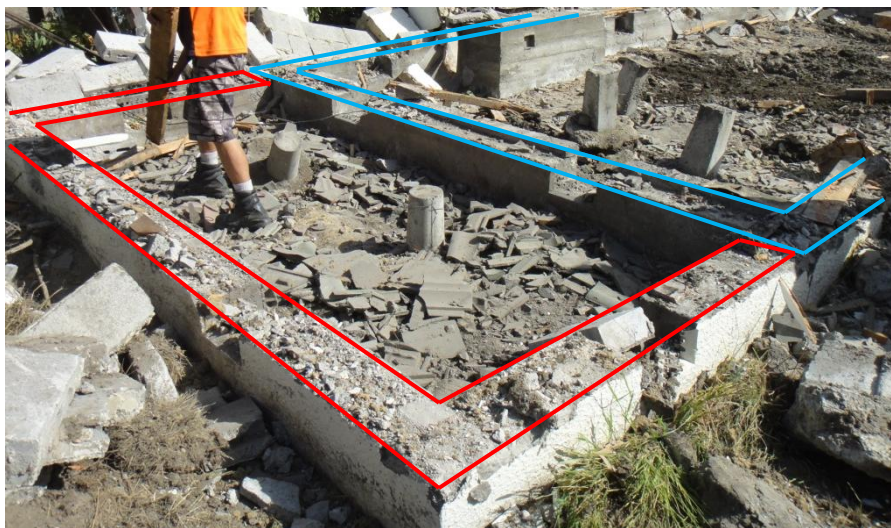
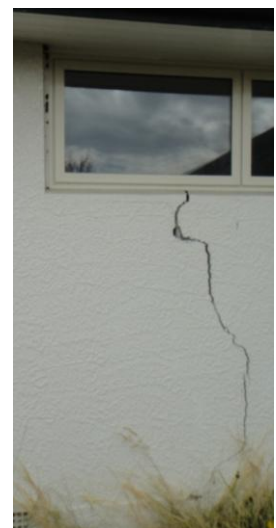
Figure 5.14. a) Perimeter foundation showing old foundation in blue and new extension in red, with no connection between the two, b) structural crack on North side of East extension, opening up to 30mm at roof level.

The concrete perimeter was well constructed, with two R16 reinforcing bars. Because of this there was very little damage to the perimeter itself, despite the significant hogging, and visible damage was concentrated in the superstructure along the Southern section. There was little sand ejecta under the house, due to the 1.7m thick crust layer found. In the absence of the extensions, overall damage and deformation of the house may have been only low to moderate, as indicated by the low level of damage to the main body of the original house. However, the unattached perimeters in the extensions, combined with heavy concrete block walls, and a heavy tile roof, caused significant structural damage to this house.

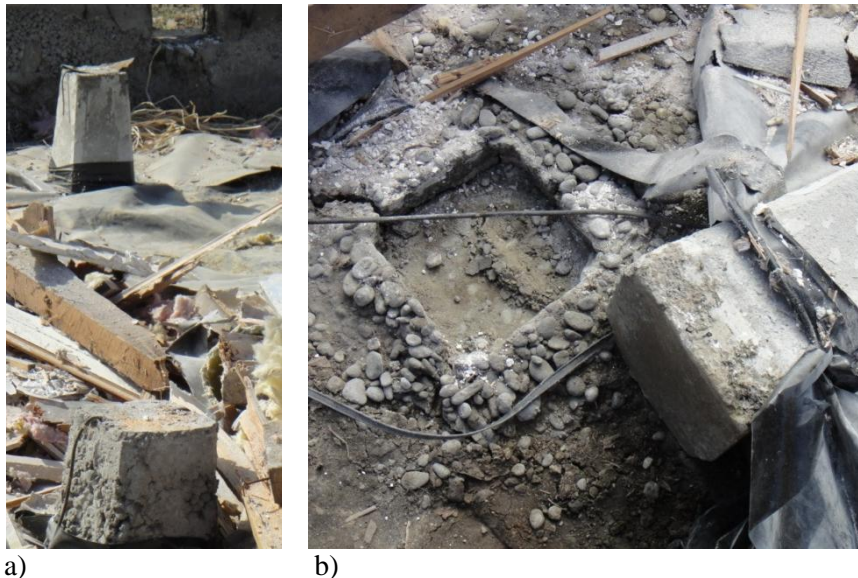
Figure 5.15. Pier details, a) upright piers showing wire hooks bent down and not used, b) pier cast only level to the ground, easily knocked out.

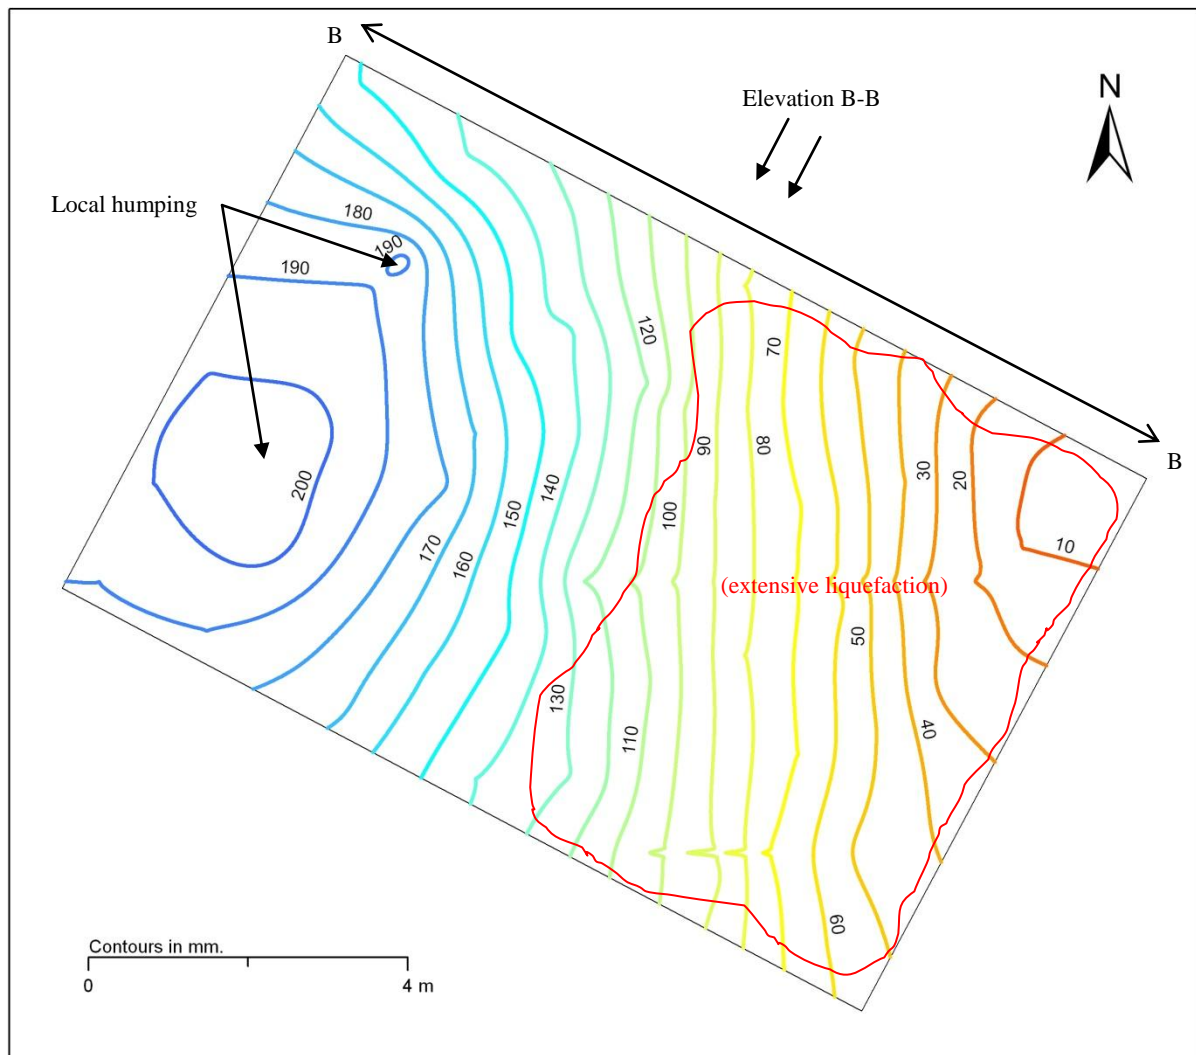
Figure 5.16. House 3 floor plan outline showing floor level contours in 10mm increments.

The building had an overall differential settlement of 200mm from the West corner down to the East corner, as shown in Figure 5.16 and Figure 5.17. This settlement was quite uniform, apart from room humping in two bedrooms at the West end, shown in Figure 5.16 and Figure 5.17. This local room humping caused some extreme slopes of 2.2° , or 0.038m/m . The general floor slopes in the direction of overall differential settlement were between $1\text{--}1.5^\circ$.

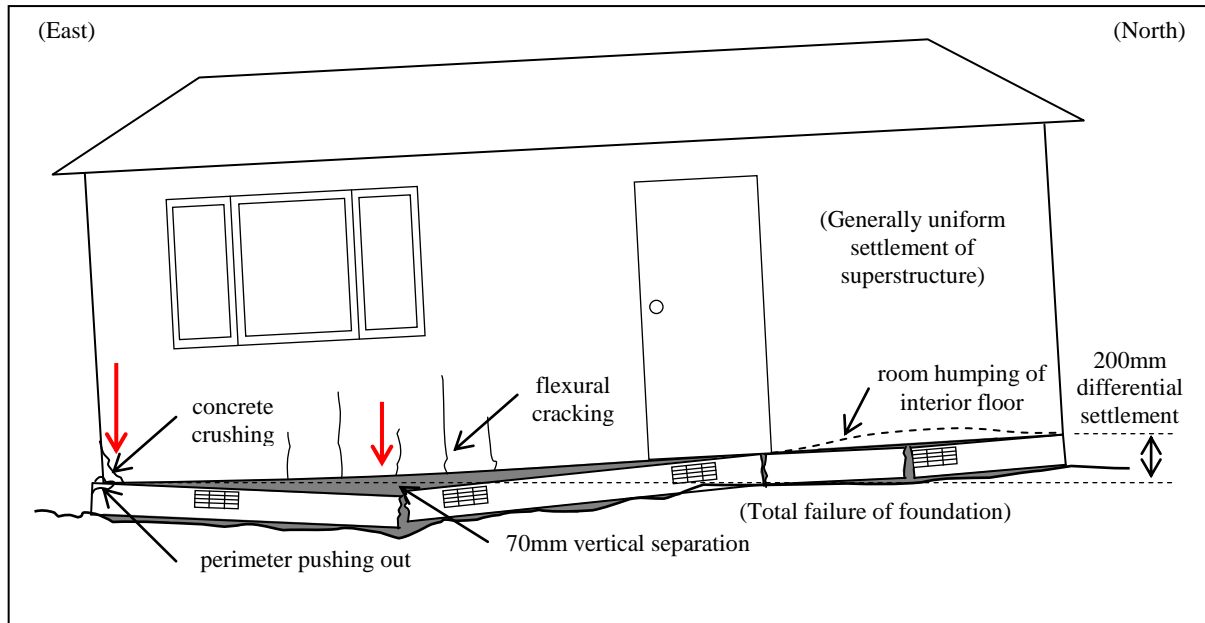
The most severe damage was to the foundation. The superstructure remained relatively intact and moved somewhat independently of the foundations, while the unreinforced concrete perimeter completely broke up in multiple locations and settled differentially (Figure 5.17). In addition to the detached piers, along two thirds of the Northeast wall (about 6m) the perimeter broke up during settlement and was completely separated from the superstructure above, leaving a gap of up to 70mm between the two. This is shown in Figure 5.17 and Figure 5.18. This has caused the wall above to bend flexurally, and has resulted in eight small tension cracks from hairline to 3mm in width along the base of the wall.

Figure 5.17. Schematic elevation B-B of the Northeast side of House #3, showing deformation and damage, including the settlement and failure of foundations, uniform tilt of superstructure and separation between foundation and superstructure causing flexural cracking in external cladding.

The superstructure, along with the timber floor and sub-floor, separated from the foundation and tilted almost as a rigid body, giving the overall differential settlement of 200mm (Figure 5.17). This near rigid body movement meant that damage to the superstructure was only low to moderate throughout the house. Outside, apart from the eight small flexural cracks, a number of minor cracks were seen in the stucco cladding at window corners, and there were a small number of vertical cracks and separation between door frames and walls. Inside the damage was minor, with hairline cracks in the plaster in most rooms. A few doors stuck open due to local room humping, but this was confined to a couple of rooms, and there was no apparent racking of door frames.

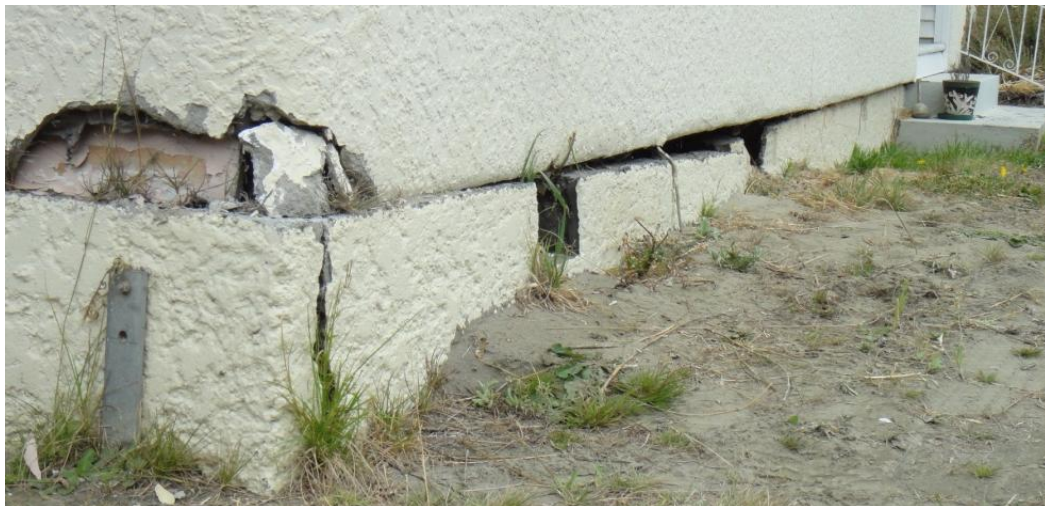
Figure 5.18. East corner looking along the Northeast wall showing separation between superstructure and concrete perimeter, and crushing at East corner.

At the East corner, the perimeter has pushed out from under the house by 40-60mm (Figure 5.17 and Figure 5.18). At this corner, and also the Southeast corner, the superstructure is pushing down onto the perimeter, causing spalling at the top of the perimeter at the corners. This is matched at the opposite West corner, where the superstructure has lifted off the perimeter by 30mm (Figure 5.19). This is a result of the perimeter settling differentially but non-uniformly to the East while the superstructure tilted uniformly in the same direction.

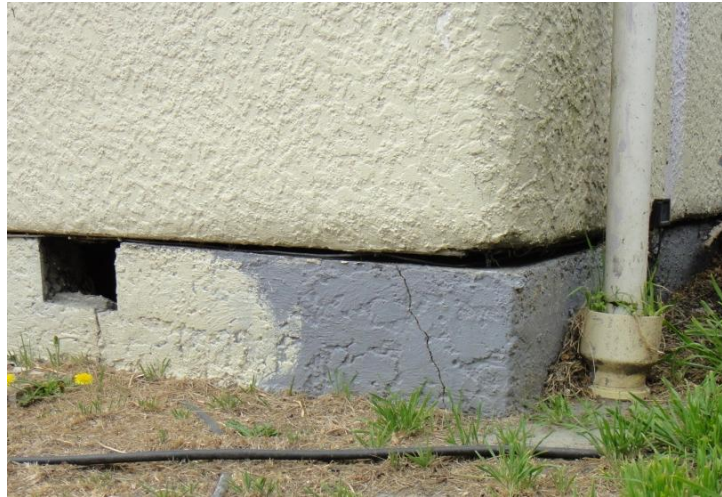
Figure 5.19. West corner showing uplift of superstructure and separation between foundation and superstructure caused by tilting.

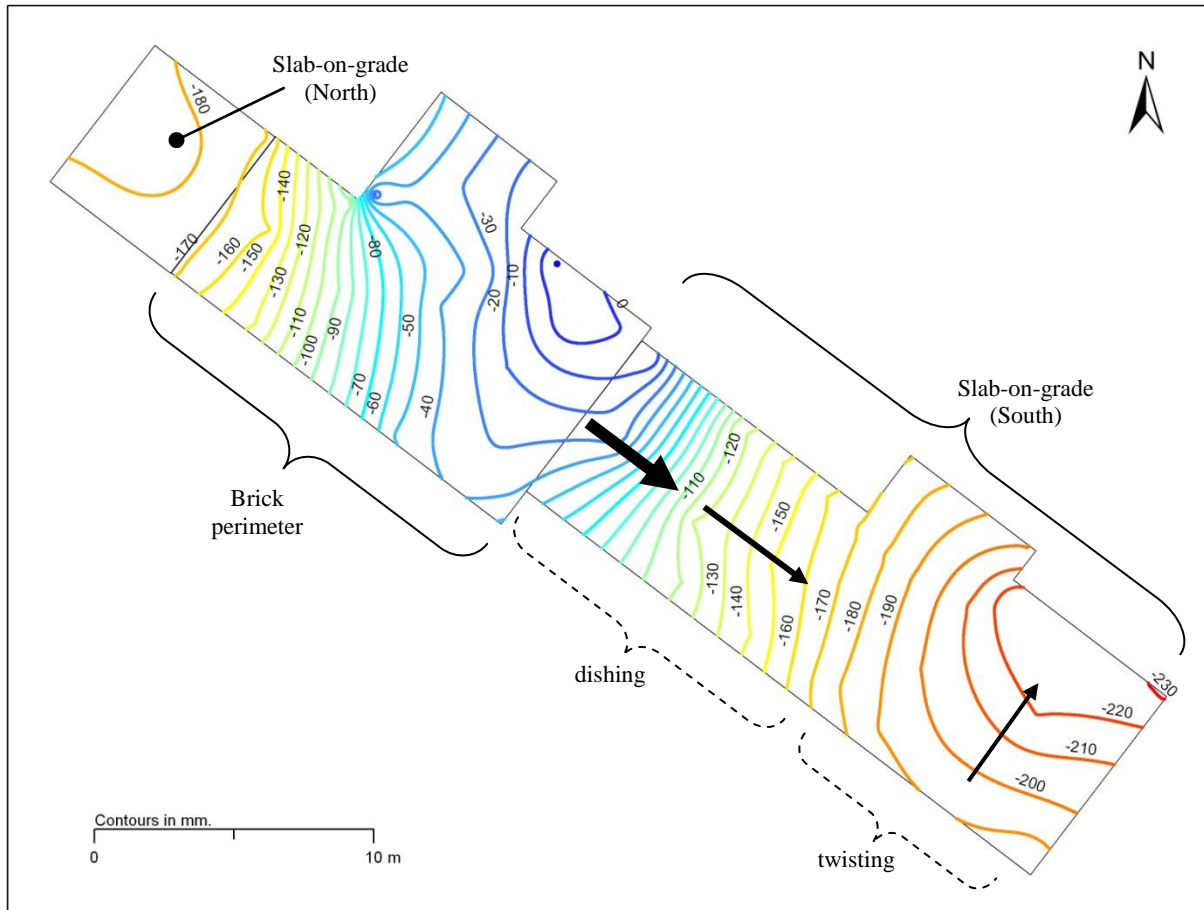
Figure 5.20. House 4 floor plan outline showing floor level contours in 10mm increments.

From the connection between the two halves of the house, the south slab had an overall differential settlement of 232mm to its Southeast end. This differential settlement was not uniform. Along the length the south slab, there is significant dishing over the northern half, shown by the change in spacing between the contour lines in Figure 5.20. The Southeast quarter of the south slab has twisted and is tilting to the Northeast, perpendicular to the rest of this slab section, shown by the orange and red contour lines in Figure 5.20.

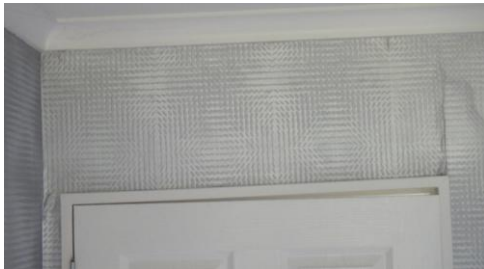
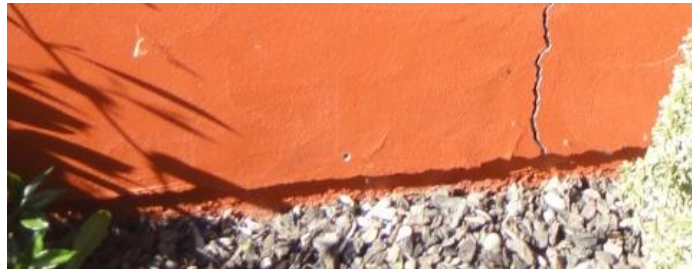
Figure 5.21. Structural damage, a) racking of door frame, b) cracking and mis-alignment of wall from concrete slab foundation.

The dishing of the south slab foundation has pulled the superstructure down with it, causing significant racking and the mis-alignment of a number of door and window frames, as seen in Figure 5.21.(a). The dishing also caused cracking and mis-alignment between the Southwest wall and the

foundation along the whole Southwest wall of the south slab, shown in Figure 5.21.(b), and nail popping and buckling of the interior plasterboard on the Southwest wall in the garage, at the South end of the wall (Figure 5.22.(a)). The twisting at the South end was not manifested in superstructure damage, as this was the garage, with no internal walls.

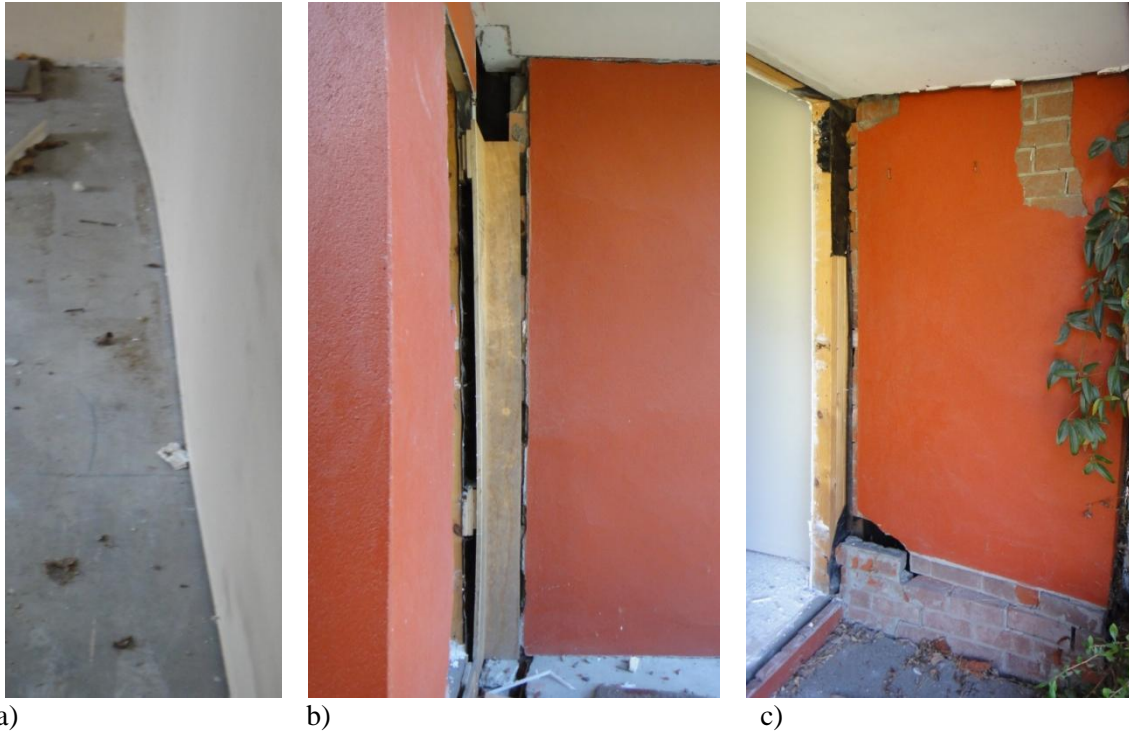
Figure 5.22. Structural damage, a) buckling of plasterboard on Southeast wall in garage and separation between two halves of house on b) South side and c) North side.

The most severe structural damage occurred at the interface between the slab and perimeter sections of the building in the middle of the house. The two parts of the house were ripped apart, due to their incompatible deformation modes. While the Southeast half of the house was tilting severely to the Southeast, as described above, the Northwest half of the house was tilting the opposite way. This caused 50-100mm of separation between the two halves of the house, as shown in Figure 5.22.(b) and (c).

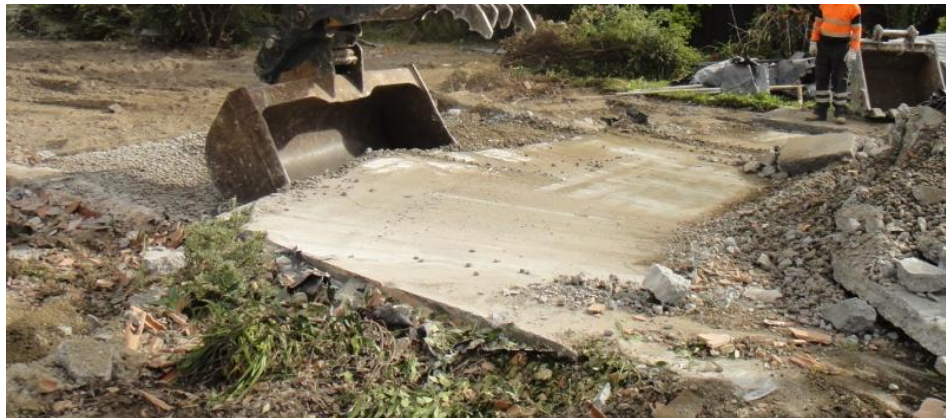
Figure 5.23. The un-cracked south slab being lifted (causing cracking), showing hard fill layer underneath.

Despite the significant differential settlement, dishing and twisting, there were no visible cracks found in the top of the concrete slab foundation (Figure 5.23). Even after the superstructure had been totally pulled off the foundation, and the excavator had driven all over it, the slab showed no signs of damage. It wasn't until the foundation was pulled up that it broke apart. This may have been due to the fact that the deformation occurred along the house, and the flexural demands (in terms of curvature) on the foundation were not great due to its very slender profile in this direction (although the underside of the slab which experienced the tension stress from the dishing could not be inspected

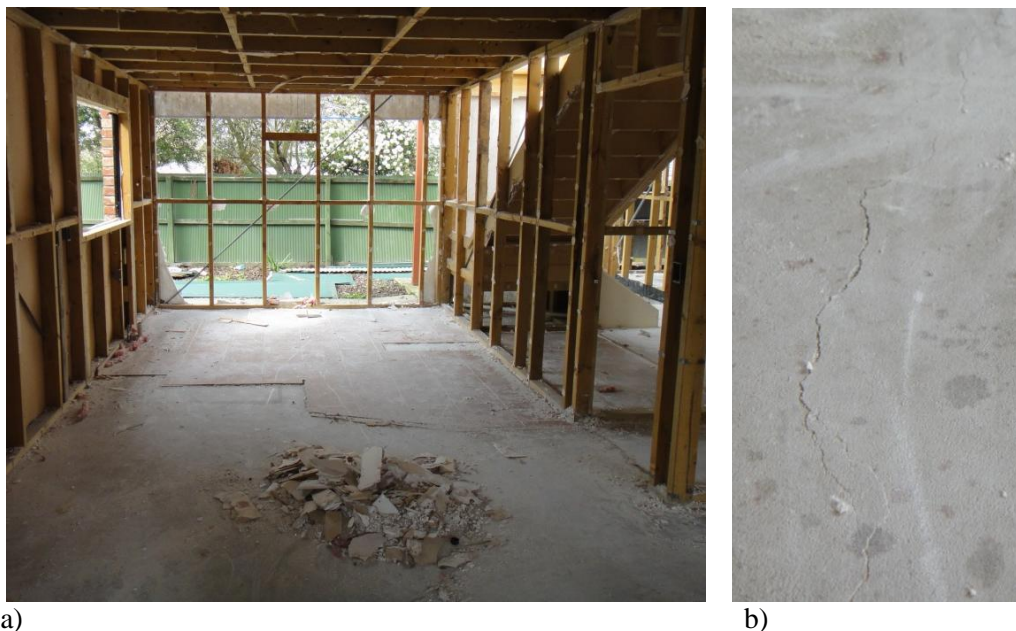
Figure 5.24. a) Overview of slab foundation in living area of House #5, b) The only crack in the floor slab.

Due to the uniform, rigid-block tilting of the house, damage to the superstructure was very low, with only a few instances of cracking in brickwork at window corners, and typical minor damage to plasterboard inside.

This deformation mode is attributed to the well-built foundation of this house, which was on average thicker than the required 100mm; up to 160mm thick in places, and well reinforced with either 665 or 663 equivalent wire mesh. It was also surrounded by wide and deep perimeter foundation walls that were well reinforced (for details see Appendix T). The house had a relatively small footprint, due to it being mostly two-storey, which also would have contributed to the rigid-block differential settlement of the house, as the well-constructed foundation would have been more able to hold together a smaller footprint building.

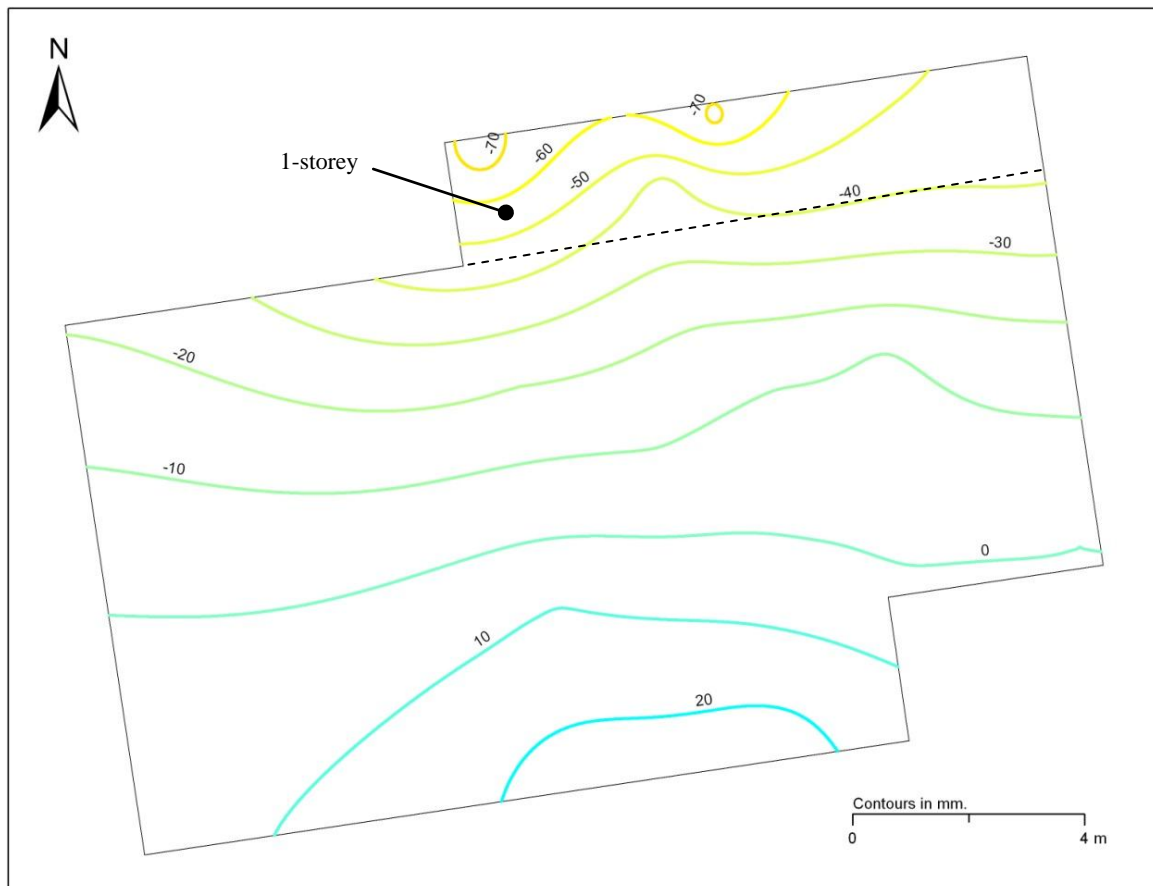
This two-storey house had a high overall differential settlement of 104mm across its widest point. This was largely uniform tilting about its major axis, as shown by Figure 5.25, although there was a one-storey section on the North side about 1.5m wide running across the house that tilted slightly more, causing some hogging in the foundation, which resulted in one hairline crack along this interface (Figure 5.24.(b)). This is illustrated in the yellow contours in Figure 5.25 being closer together, indicating steeper slopes.

Figure 5.25. House #5 floor plan outline showing floor level contours in 10mm increments.

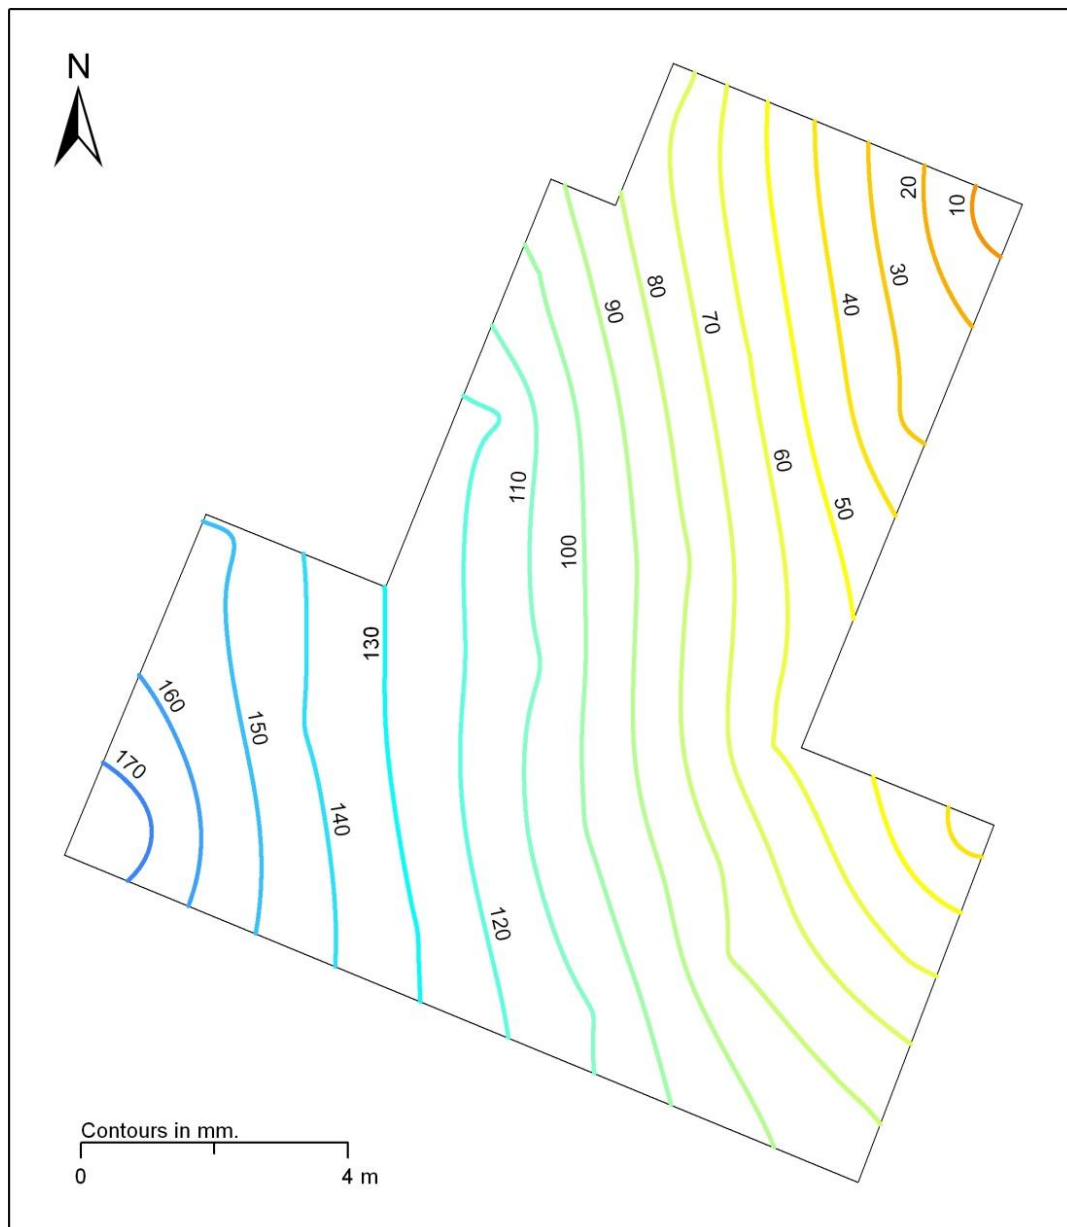
House #6 also had high overall differential settlement of 180mm from the Southwest corner to the Northeast corner (Figure 5.26). As for House #5, this differential settlement was close to uniform, as shown by the evenly spaced contour lines in Figure 5.26. There was some minor local hogging identified with the smart level in the North section of the house in the North-South direction (for tilt measurements see Appendix T), and there was extensive minor cracking right across the floor slab throughout this area of the house, shown in . However, these cracks were at most 1mm wide, and were not serious, given the overall uniform nature of the settlement. As the cracks were in all directions, and intersecting randomly, it is hard to say whether they were caused by the permanent differential settlement, or during the earthquake.

Figure 5.26. House #6 floor plan outline showing floor level contours in 10mm increments.

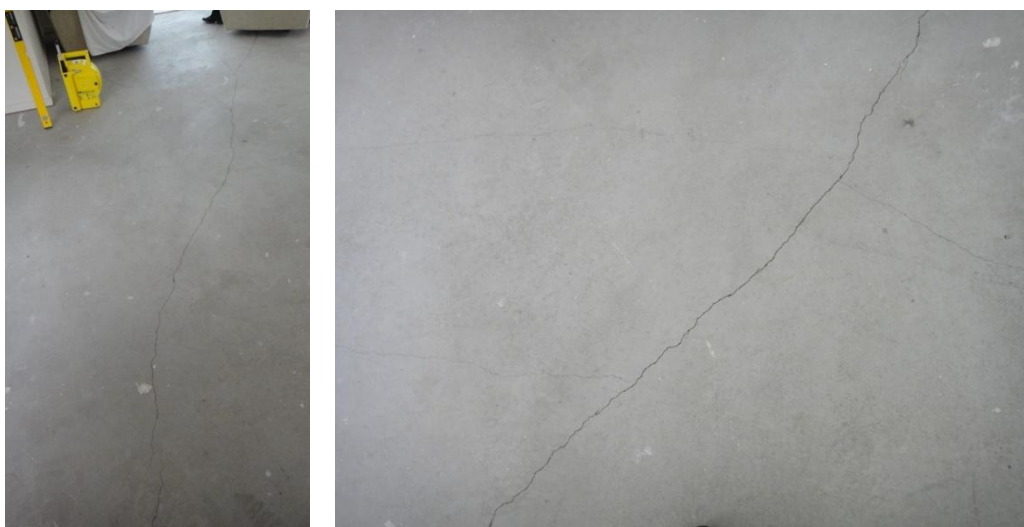
Figure 5.27. Extensive minor cracking in concrete floor slab in House #6.

Despite the high differential settlement, this house also only suffered low levels of superstructure damage. This is because the uniform nature of the differential settlement does not put any stress on the structural components. Damage to the superstructure was confined to minor cracking in plasterboard inside, and low levels of cracking and separation in a few locations in the external brick cladding outside.

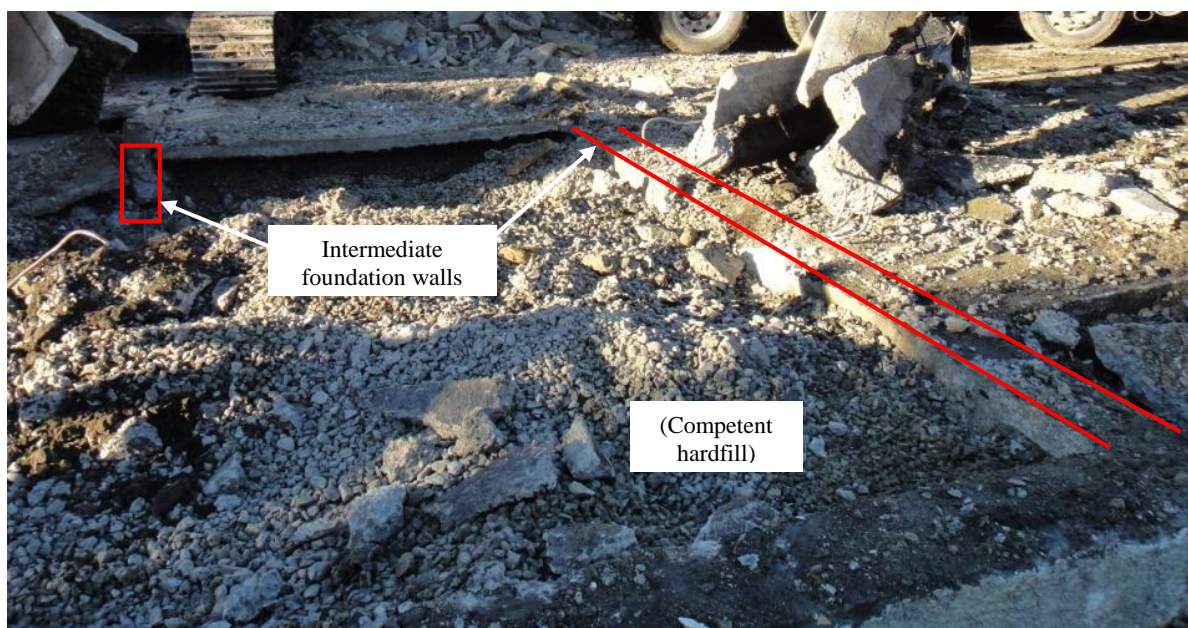
The main reason for the good performance of this house is that the foundation was constructed very well. Although the floor slab was unreinforced and the minimum of 100mm thick everywhere, it was constructed with good, well-graded, angular aggregate and stayed together well when lifted. The 50mm covering of wood-chip/cement was firmly attached to the slab and would have provided extra stiffness and strength against deformation. The fill under the slab was also very competent AP40 or AP60, uniformly graded angular gravel that was well compacted and provided a solid base for the foundation. The perimeter foundation walls were large and well reinforced, and there were also intermediate foundation walls under every load-bearing wall that provided significant extra strength and stiffness to the foundation system (Figure 5.28).

Figure 5.28. Uplifted slab, showing competent hardfill and intermediate foundation walls.

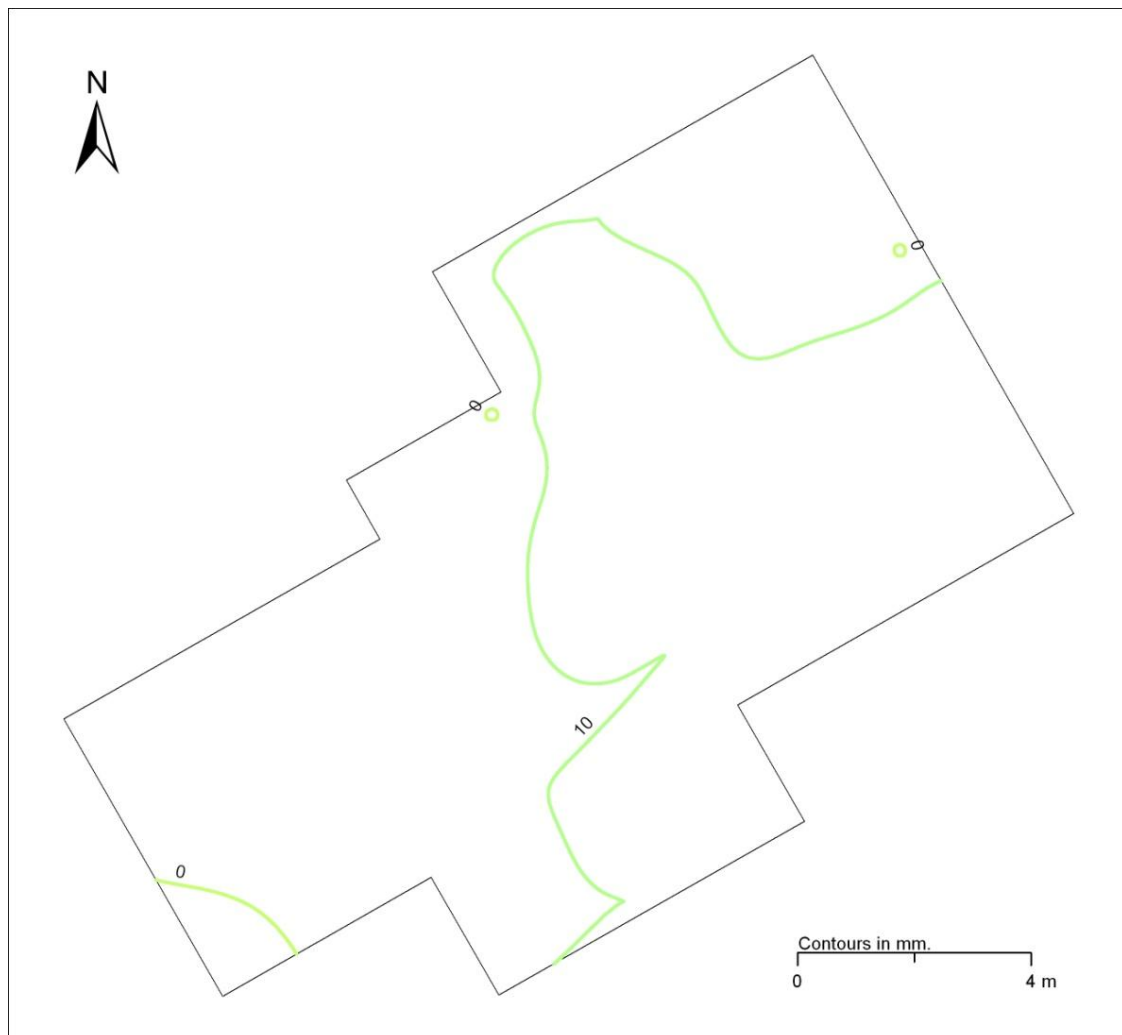
The overall structural damage and deformation in this house was low, indicating good performance. Foundation damage was very low, as the building had a total overall differential settlement of only 28mm over the length of the house (Figure 5.29), with a maximum local floor slope of 0.4° recorded in two locations, the rest of the readings being 0° , 0.1° or 0.2° . This was despite being in an area where major land damage occurred.

Figure 5.29. House #7 floor plan outline showing floor level contours in 10mm increments.

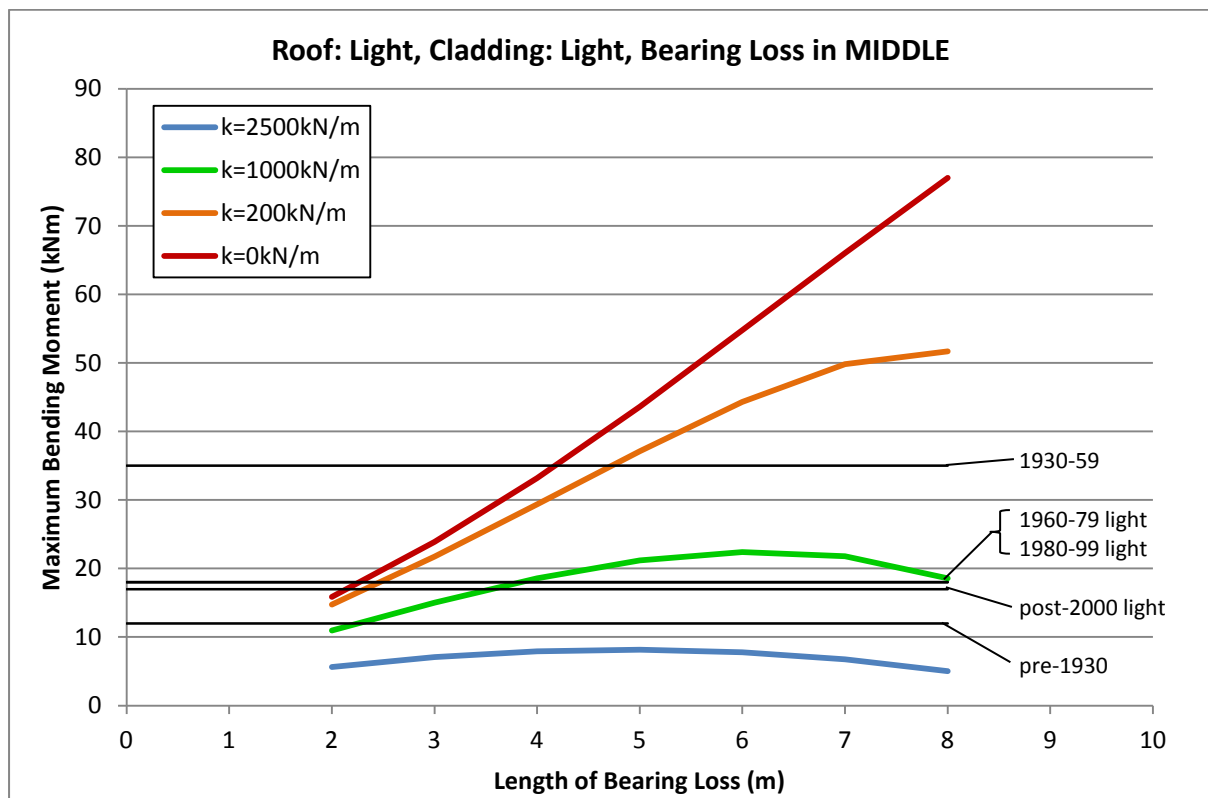
Figure 6.9. Moment demands for light roof and cladding for different levels and lengths of bearing loss in centre. Yield capacities of the corresponding perimeter sections are also shown.

For light claddings the demands were significantly lower. This meant that the 1930-59 section, which does not change for cladding type, performed better. It will not yield under any length of 80% bearing loss, but will still yield after more than 4.5m of 96% bearing loss or 4m of 100% bearing loss with a light roof (Figure 6.9). With a heavy roof, these lengths reduce to 3.7m and 3.3m for 96% and 100% bearing loss respectively (Appendix S.1, Figure A. 132). The three newest foundations do not get any benefit from the reduced demands of a lighter structure, as their strengths are also reduced. This has resulted in almost identical performance with a light structure for these three sections when compared to heavy claddings. For light claddings with heavy roofs (Appendix S.1, Figure A. 132), their performance is worse, with 80% bearing loss over 2.5-3m causing yielding. The pre-1930 section still performs poorly, although with a light cladding it can resist 50% bearing loss over any length.

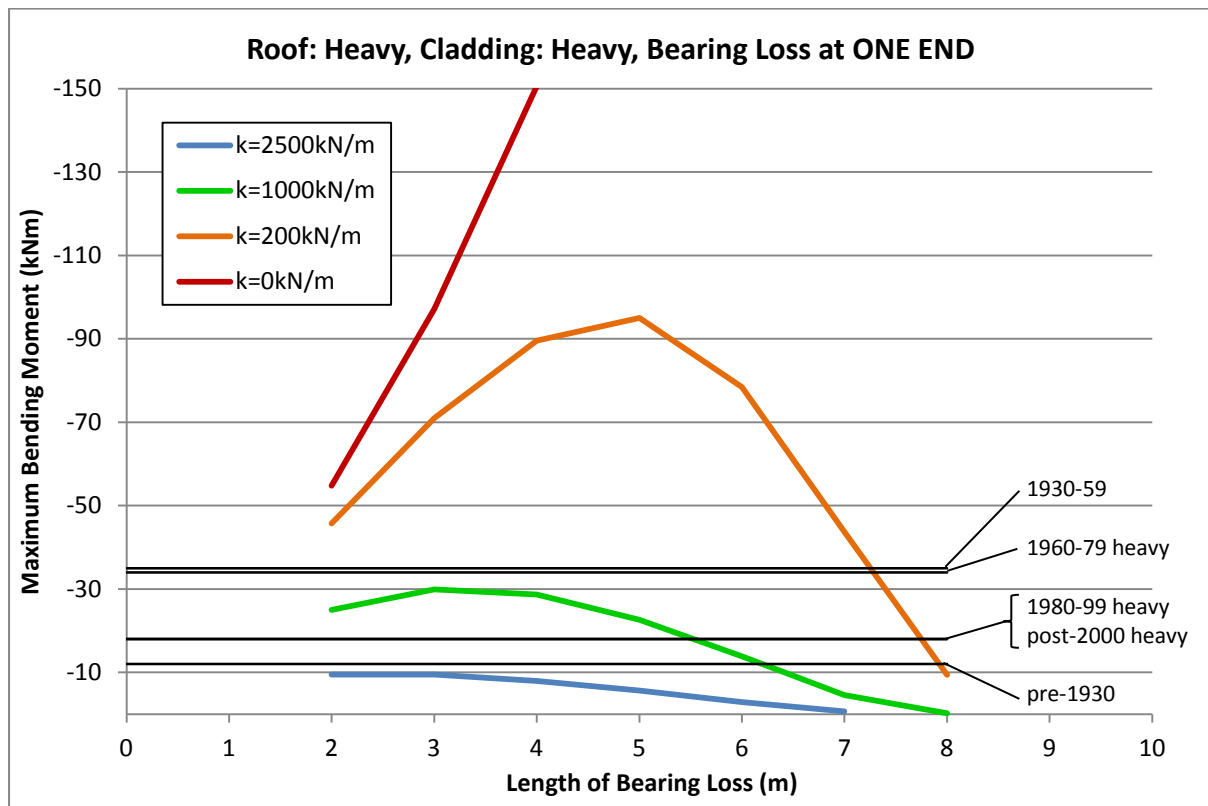
Figure 6.10. Moment demands for heavy roof and heavy cladding for different levels and lengths of bearing loss at one end. Yield capacities of the corresponding perimeter sections are also shown.

For heavy claddings, shown in Figure 6.10, the moment demands for 96% and 100% bearing loss exceed all section yield capacities for almost all lengths. The exception is for the 1930-59 and 1960-79 sections which can resist 96% bearing loss over more than 7.3m without yielding, due to the sharp drop-off in demand from 6m length. Although the pre-1930 section exceeds the 50% reduction demands, these are small due to the influence of double curvature already mentioned, and the performance of these old foundations is still very poor. The 1980-99 and post-2000 sections can resist 50% bearing loss and more than 5.5m of 80% bearing loss without yielding, which also can be seen as poor performance. This is due to their lower section capacities for the negative moment demands from this loading scenario, as shown in Table 6.8.

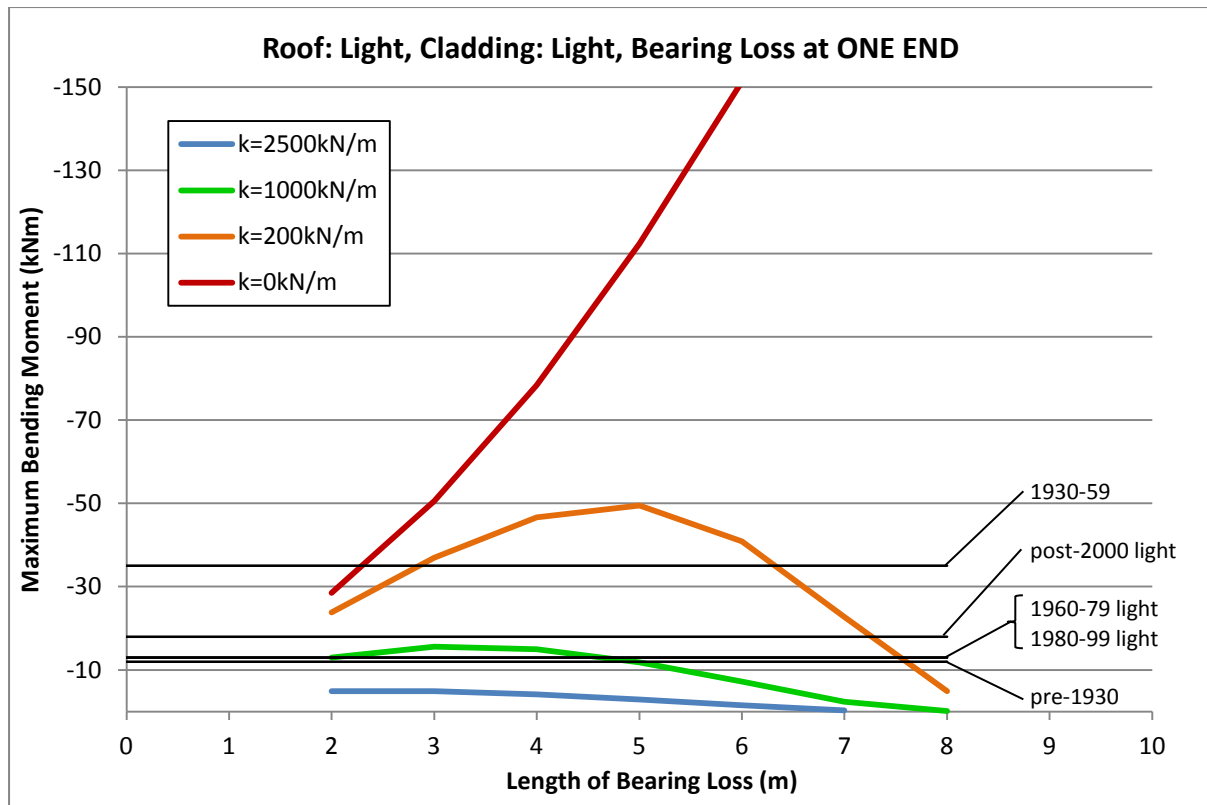
Figure 6.11. Moment demands for light roof and light cladding for different levels and lengths of bearing loss at one end. Yield capacities of the corresponding perimeter sections are also shown.

For light claddings, shown in Figure 6.11, the loads are significantly smaller. This is the same as with bearing loss in the centre, except for 100% bearing loss, which behaves differently due to the nature of the cantilever loading. For light roofs (Figure 6.11) the 1930-59 section yield capacity exceeds the demand from 96% bearing loss for less than 3m and more than 6.5m, but for heavy roofs (shown in Appendix S.2, Figure A. 136) the section can only resist less than 2m and more than 7m of 95% loss without yielding. The overall performance of the post-2000 section improves so that it can resist 80% bearing loss over any length without yielding. This is because for negative moment demand, its reverse yield capacity does not change for light claddings (see Table 6.8), so relatively, it performs better under the reduced moment demands of light cladding. The performance of 1960-79 and 1980-99 sections is somewhat better, due to the reduced demands for light claddings, however, their reduced yield capacities for light claddings means they perform almost as badly as the pre-1930 section, which is still considered to perform poorly.
